Manhole Inspection Summary

Manhole # S39AA_018MH

Insp Date: **6/17/08 9:40 AM**

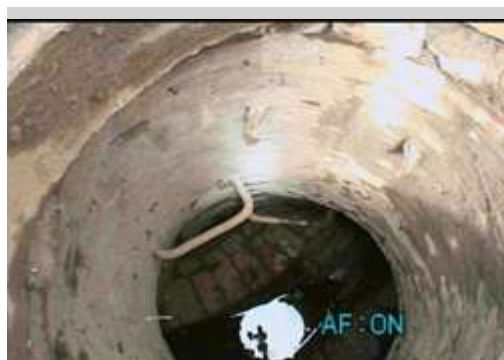
Defect 3

Steps Count: **4** Missing: **1** ☐ Corroded

steps

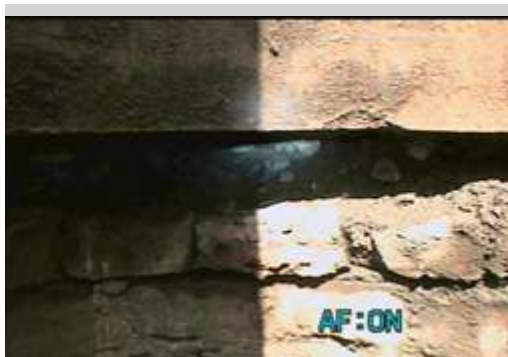
Defect 2

Chimney / Frame Adjustment ☒ Exists Material: **Brick and Concrete** ☐ Parged Height: **4** (in.)
Condition: ☐ Sound ☒ **Cracked** ☐ Root Intrusion ☒ **Loose Brick** ☒ **Deteriorated**
Infiltration: ☒ None ☐ Joint ☐ Cracks ☐ Mortar ☐ Roots ☐ Wall

Chimney Loose Bricks, Cracked and Deteriorating

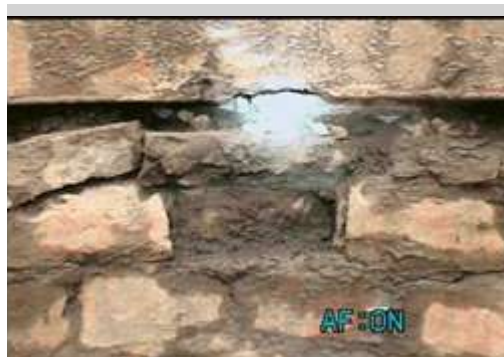
Defect 1

Corbel Material: **Brick** ☐ Parged Type: **Concentric/Eccentric**
Condition: ☐ Sound ☐ Cracked ☐ Root Intrusion ☒ **Loose Brick** ☐ Deteriorated
Infiltration: ☐ None ☐ Joint ☐ Cracks ☐ Mortar ☐ Roots ☒ **Wall**

Corbel Loose Bricks, Infiltration
